**Flood Control Project Maintenance
Levee Inspections**

Maintenance Issue Types Only, Levee Inspection Report By Mile - Spring 2017

Reclamation District No. 2092 Dos Rios

Waterway	Bank	Unit Miles	Inspection Start/End	Inspector
Unit No. 01 San Joaquin River	Right	3.71	04/07/2017 04/07/2017	Pavel Kazi

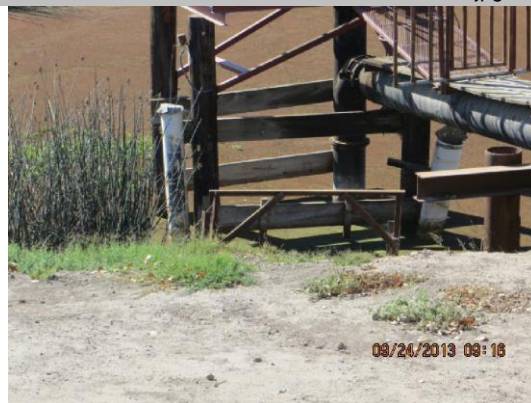
Photo 2 of 3 : UCIP_SP_2017_27123_50241.jpg

LM Start	0.18	Rating **	M	Issue No.	973 (cont)
LM End	0.18	Issue Type +	Ma	Location *	N/A
Category	Supplemental			GPS Latitude/Longitude	
				Start	End
Item	DWR UCIP LMA Responsibility			37.602031 °	37.602031 °
				-121.161249 °	-121.161249 °
DWR ID					
Comment Code					
Inspector Comment					
FS_ID:27123 DS_ID:20561 EP_NO: N/A Repair Type: Non-Urgent Crossing Status: Found UCIP Comments: Pipe rusted through at headwall on LS toe. Good candidate for video inspection. FIELD_STRUCT_DESC: 60-inch corrugated metal drainpipe through levee 19.0 feet below crown. Flap gate on the waterward end. Slide gate in 80-inch corrugated metal pipe riser on the waterward slope. Concrete "U" headwalls on both ends. Originally included in the 1961 O&M manual. FS Date: 1/16/2014 12:03:14 PM

Concrete headwall on LS toe in front of pump on pier.

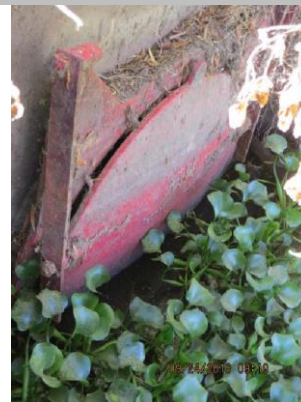
Photo 3 of 3 : UCIP_SP_2017_27123_50240.jpg

Flapgate and headwall on WS toe.

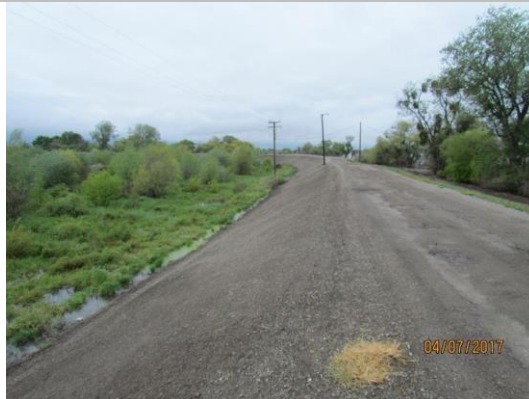
Photo 1 of 1 : SP_2017_RD2092_116_17_20170417_00036.jpg

LM Start	0.38	Rating **	A	Issue No.	17
LM End	0.38	Issue Type +	Ma	Location *	LS
Category	Earthen Levee			GPS Latitude/Longitude	
				Start	End
Item	Vegetation			37.601283 °	37.601283 °
				-121.164806 °	-121.164806 °
DWR ID	DWR_RD2092_01_s_2017_17				
Comment Code					
V1 : Control annual grass and weeds on the levee slopes and easements.					
Inspector Comment					
Acceptable vegetation.

View of the landside of the levee. Spring 2017

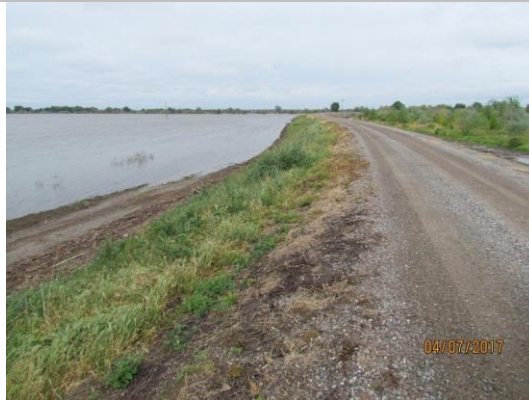
Photo 1 of 1 : SP_2017_RD2092_116_19_20170417_00044.jpg

LM Start	0.87	Rating **	M	Issue No.	19
LM End	1.31	Issue Type +	Ma	Location *	WS
Category	Earthen Levee			GPS Latitude/Longitude	
				Start	End
Item	Vegetation			37.595725 °	37.590537 °
				-121.168175 °	-121.163975 °
DWR ID	DWR_RD2092_01_s_2017_19				
Comment Code					
V1 : Control annual grass and weeds on the levee slopes and easements.					
Inspector Comment

View of vegetation on the waterside of the levee.

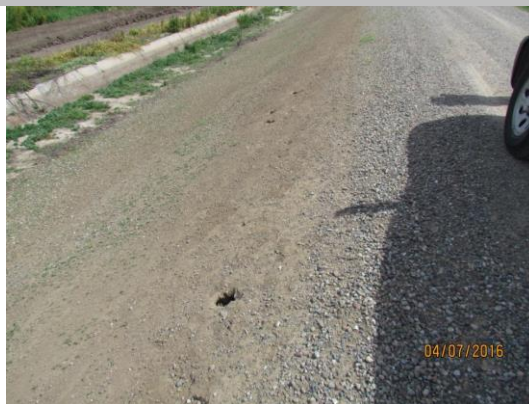
Photo 1 of 1 : SP_2017_RD2092_116_15_20170327_00004.jpg

LM Start	1.21	Rating **	M	Issue No.	15
LM End	1.21	Issue Type +	Ma	Location *	LS
Category	Earthen Levee			GPS Latitude/Longitude	
				Start	End
Item	Animal Control			37.591293 °	37.591293 °
				-121.165434 °	-121.165434 °
DWR ID	DWR_RD2092_01_s_2016_15				
Comment Code					
A3 : No rodents visible, but rodent burrows visible; need to backfill and compact or grout burrows.					
Inspector Comment

View of a rodent hole on the landside of the levee.

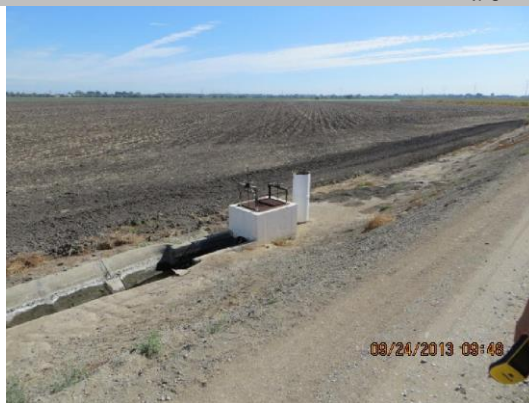
Photo 2 of 2 : UCIP_SP_2017_20889_35212.jpg

Concrete distribution box at concrete canal on LS toe.

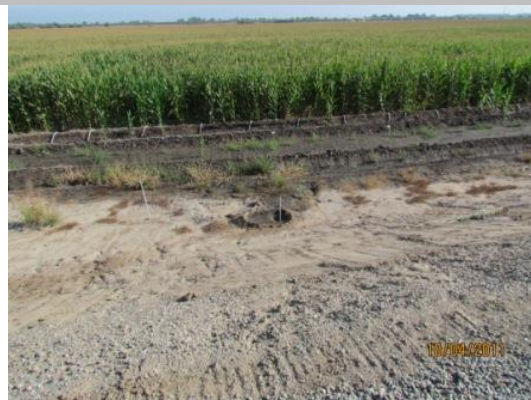
Photo 2 of 2 : SP_2017_RD2092_116_10_20170327_00003.jpg

A sand boil was found on the landside of the levee. It was caused by a pipe leak couple of feet below the boil location. LMA was notified to repair it as soon as possible. The picture was taken from the crown looking upstream.

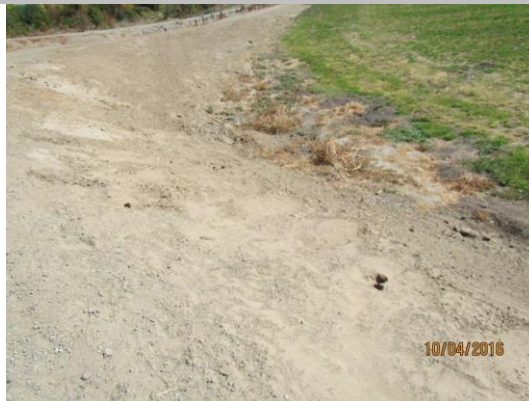
Photo 1 of 1 : SP_2017_RD2092_116_16_20170327_00005.jpg

LM Start	1.56	Rating **	M	Issue No.	16
LM End	1.56	Issue Type +	Ma	Location *	LS
Category	Earthen Levee			GPS Latitude/Longitude	
				Start	End
Item	Animal Control			37.587593 °	37.587593 °
				-121.162431 °	-121.162431 °
DWR ID	DWR_RD2092_01_f_2016_16				
Comment Code					
A3 : No rodents visible, but rodent burrows visible; need to backfill and compact or grout burrows.					
Inspector Comment

View of rodent holes on the landside of the levee looking downstream.

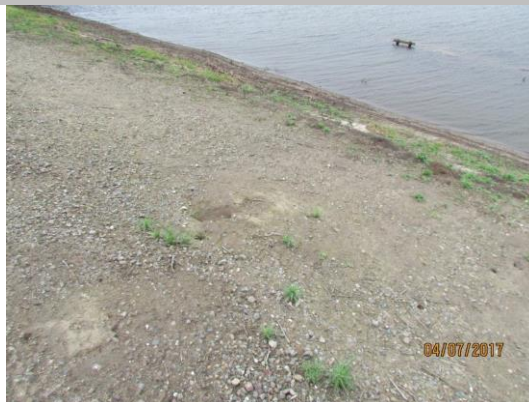
Photo 1 of 1 : SP_2017_RD2092_116_38_20170417_00043.jpg

LM Start	1.58	Rating **	M	Issue No.	38
LM End	1.58	Issue Type +	Ma	Location *	WS
Category	Earthen Levee			GPS Latitude/Longitude	
				Start	End
Item	Animal Control			37.587282 °	37.587282 °
				-121.162641 °	-121.162641 °
DWR ID	DWR_RD2092_01_s_2017_38				
Comment Code					
A3 : No rodents visible, but rodent burrows visible; need to backfill and compact or grout burrows.					
Inspector Comment

View of a rodent hole on the waterside of the levee.

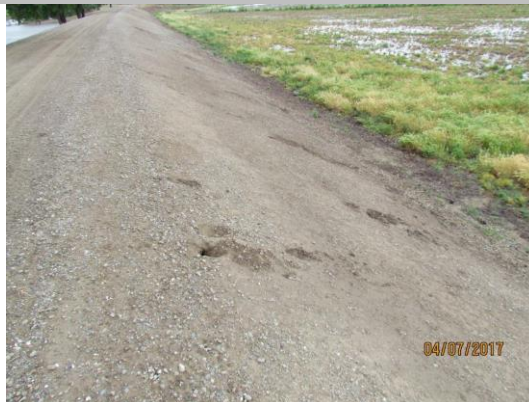
Photo 1 of 1 : SP_2017_RD2092_116_21_20170417_00037.jpg

LM Start	1.66	Rating **	M	Issue No.	21
LM End	1.66	Issue Type +	Ma	Location *	LS
Category	Earthen Levee			GPS Latitude/Longitude	
				Start	End
Item	Animal Control			37.586267 °	37.586267 °
				-121.163209 °	-121.163209 °
DWR ID	DWR_RD2092_01_s_2017_21				
Comment Code					
A3 : No rodents visible, but rodent burrows visible; need to backfill and compact or grout burrows.					
Inspector Comment

View of rodent holes on the landside of the levee looking downstream.

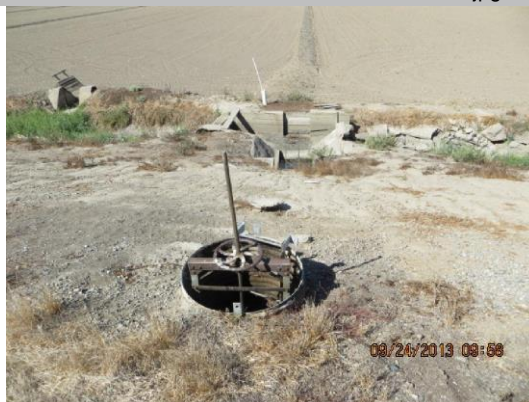
Photo 1 of 3 : UCIP_SP_2017_20891_35216.jpg

LM Start	1.69	Rating **	A/W	Issue No.	977
LM End	1.69	Issue Type +	Ma	Location *	LS
Category	Supplemental			GPS Latitude/Longitude	
				Start	End
Item	DWR UCIP LMA Responsibility			37.585938 °	37.585938 °
				-121.163348 °	-121.163348 °
DWR ID					
Comment Code					
Inspector Comment					
FS_ID:20891 DS_ID:20563 EP_NO: N/A Repair Type: No Action Needed Crossing Status: Found UCIP Comments: FIELD_STRUCT_DESC: 24-inch corrugated metal pipe through levee 14.0 feet below crown. Slide gate in corrugated metal pipe riser on the waterward slope. Concrete "U" headwall at the landward toe. Originally included in the 1961 O&M manual. FS Date: 9/24/2013

Slide gate in 36-inch CMP riser on WS slope.

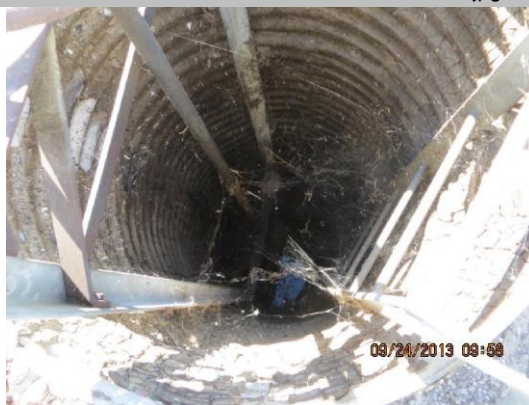
Photo 2 of 3 : UCIP_SP_2017_20891_35215.jpg

Slide gate in 36-inch CMP riser on WS slope.

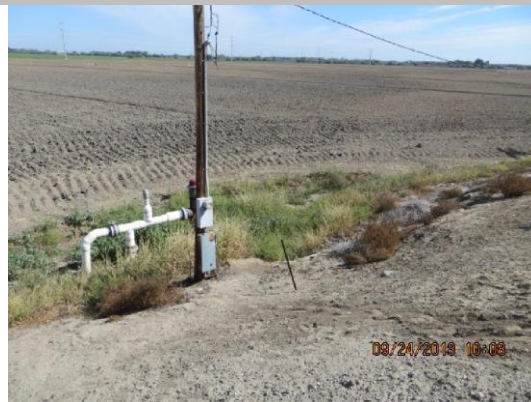
Photo 1 of 2 : UCIP_SP_2017_20904_35221.jpg

LM Start	2.07	Rating **	A/W	Issue No.	978
LM End	2.07	Issue Type +	Ma	Location *	CR
Category	Supplemental			GPS Latitude/Longitude	
				Start	End
Item	DWR UCIP LMA Responsibility			37.584212 °	37.584212 °
				-121.158347 °	-121.158347 °
DWR ID					
Comment Code					
Inspector Comment					
FS_ID:20904 DS_ID:20564 EP_NO: N/A Repair Type: No Action Needed Crossing Status: Found UCIP Comments: FIELD_STRUCT_DESC: *ABANDONED* 30-inch corrugated metal pipe through levee 15.0 feet below crown. Flap gate on the waterward end. Concrete "U" headwalls on both ends. Filled with concrete on LS toe. Originally included in the 1961 O&M manual. FS Date: 9/24/2013

Pipe and concrete headwall visible on LS toe to right of powerpole.

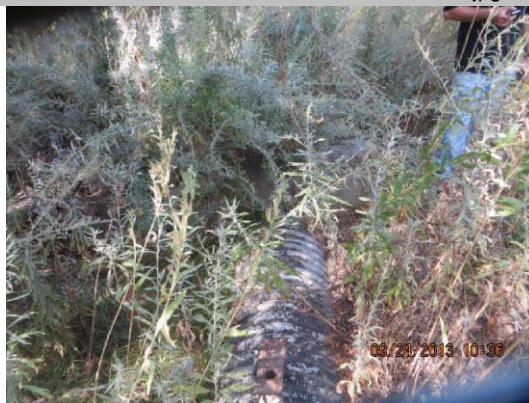
Photo 1 of 3 : UCIP_SP_2017_20943_35251.jpg

LM Start	2.40	Rating **	M	Issue No.	981
LM End	2.40	Issue Type +	Ma	Location *	CR
Category	Supplemental			GPS Latitude/Longitude	
				Start	End
Item	DWR UCIP LMA Responsibility			37.580426 °	37.580426 °
				-121.156798 °	-121.156798 °
DWR ID					
Comment Code					
Inspector Comment					
FS_ID:20943 DS_ID:20567 EP_NO: N/A Repair Type: Non-Urgent Crossing Status: Found UCIP Comments: Appears abandoned and if so should be done so properly. FIELD_STRUCT_DESC: *ABANDONED* 24-inch corrugated metal drain pipe through levee 15.0 feet below crown. Flap gate on the waterward end. Concrete "U" headwall on the waterward end and concrete headwall on LS toe next to pump. Originally included in the 1961 O&M manual. FS Date: 9/24/2013

24-inch pipe visible on WS berm.

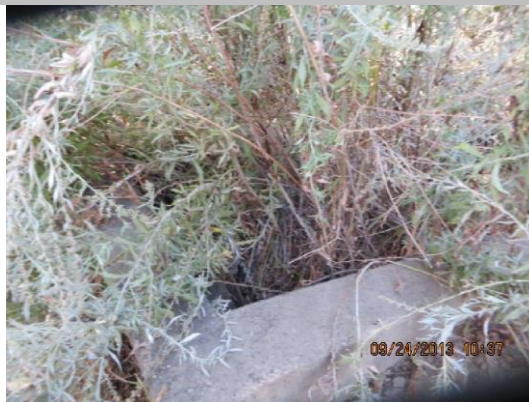
Photo 2 of 3 : UCIP_SP_2017_20943_35250.jpg

Concrete U-shaped headwall and flapgate on WS berm.

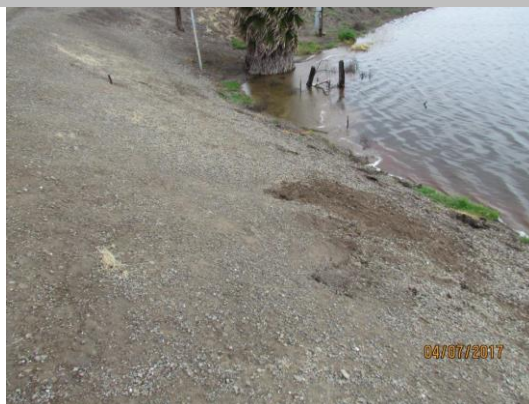
Photo 1 of 1 : SP_2017_RD2092_116_31_20170417_00038.jpg

LM Start	2.41	Rating **	M	Issue No.	31
LM End	2.41	Issue Type +	Ma	Location *	LS
Category	Earthen Levee			GPS Latitude/Longitude	
				Start	End
Item	Animal Control			37.580292 °	37.580292 °
				-121.156847 °	-121.156847 °
DWR ID	DWR_RD2092_01_s_2017_31				
Comment Code					
A3 : No rodents visible, but rodent burrows visible; need to backfill and compact or grout burrows.					
Inspector Comment

View of rodent holes on the landside slope of the levee looking downstream. Spring 2017

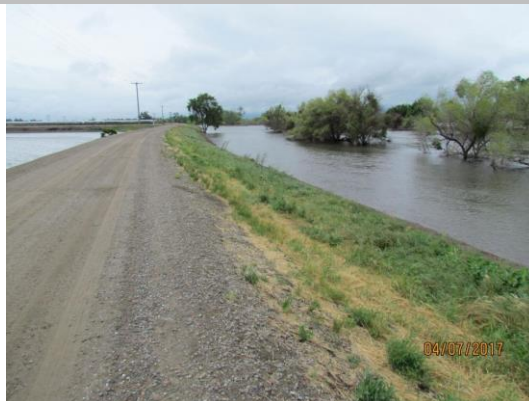
Photo 1 of 1 : SP_2017_RD2092_116_32_20170417_00039.jpg

LM Start	2.49	Rating **	M	Issue No.	32
LM End	2.72	Issue Type +	Ma	Location *	WS
Category	Earthen Levee			GPS Latitude/Longitude	
				Start	End
Item	Vegetation			37.579149 °	37.575796 °
				-121.156989 °	-121.157220 °
DWR ID	DWR_RD2092_01_s_2017_32				
Comment Code					
V1 : Control annual grass and weeds on the levee slopes and easements.					
Inspector Comment

View of vegetation on the waterside slope of the levee. Spring 2017

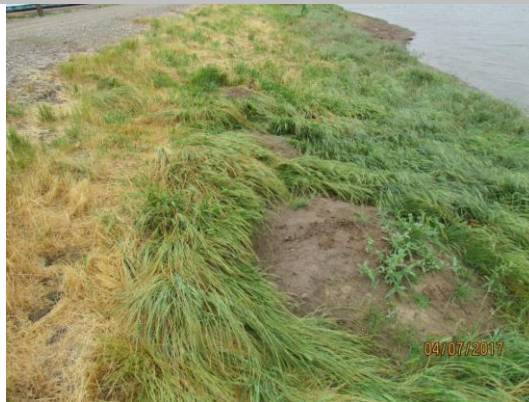
Photo 1 of 1 : SP_2017_RD2092_116_36_20170417_00042.jpg

LM Start	2.61	Rating **	U	Issue No.	36
LM End	2.61	Issue Type +	Ma	Location *	WS
Category	Earthen Levee			GPS Latitude/Longitude	
				Start	End
Item	Animal Control			37.577522 °	37.577522 °
				-121.157126 °	-121.157126 °
DWR ID	DWR_RD2092_01_s_2017_36				
Comment Code					
A3 : No rodents visible, but rodent burrows visible; need to backfill and compact or grout burrows.					
Inspector Comment

View of a rodent hole on the waterside slope of the levee.

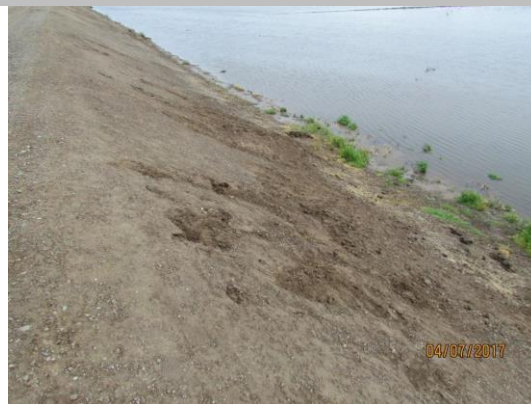
Photo 1 of 1 : SP_2017_RD2092_116_34_20170417_00040.jpg

LM Start	2.62	Rating **	M	Issue No.	34
LM End	2.62	Issue Type +	Ma	Location *	LS
Category	Earthen Levee			GPS Latitude/Longitude	
				Start	End
Item	Animal Control			37.577364 °	37.577364 °
				-121.157131 °	-121.157131 °
DWR ID	DWR_RD2092_01_s_2017_34				
Comment Code					
A3 : No rodents visible, but rodent burrows visible; need to backfill and compact or grout burrows.					
Inspector Comment

View of rodent holes on the landside slope of the levee looking downstream. Spring 2017

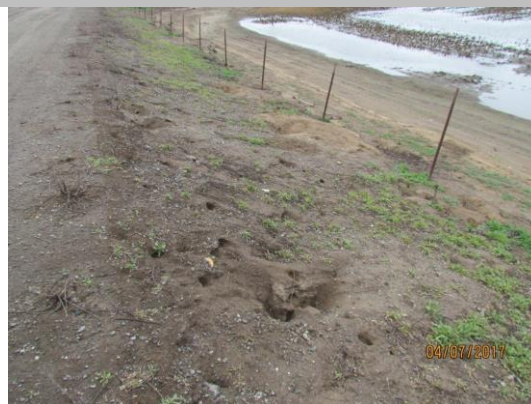
Photo 1 of 1 : SP_2017_RD2092_116_35_20170417_00041.jpg

LM Start	2.82	Rating **	U	Issue No.	35
LM End	2.82	Issue Type +	Ma	Location *	WS
Category	Earthen Levee			GPS Latitude/Longitude	
				Start	End
Item	Animal Control			37.574869 °	37.574869 °
				-121.156247 °	-121.156247 °
DWR ID	DWR_RD2092_01_s_2017_35				
Comment Code					
A3 : No rodents visible, but rodent burrows visible; need to backfill and compact or grout burrows.					
Inspector Comment

View of multiple rodent holes on the waterside slope of the levee. Spring 2017

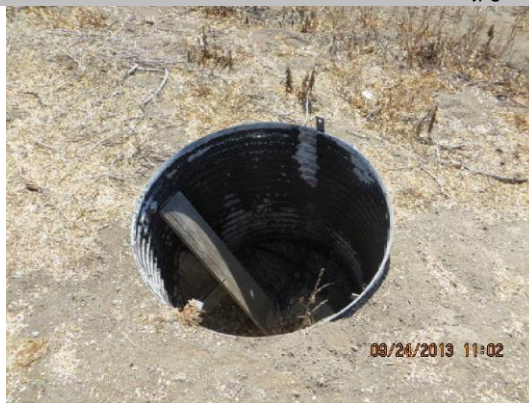
Photo 1 of 3 : UCIP_SP_2017_20945_35261.jpg

LM Start	3.47	Rating **	M	Issue No.	984
LM End	3.47	Issue Type +	Ma	Location *	WS
Category	Supplemental			GPS Latitude/Longitude	
				Start	End
Item	DWR UCIP LMA Responsibility			37.573304 °	37.573304 °
				-121.144747 °	-121.144747 °
DWR ID					
Comment Code					
Inspector Comment					
FS_ID:20945					
DS_ID:20572					
EP_NO: N/A					
Repair Type: Non-Urgent					
Crossing Status: Found					
UCIP Comments: This pipe appears abandoned and if so, should be done so properly.					
FIELD_STRUCT_DESC: *ABANDONED* 36-inch corrugated metal pipe through levee 11.0 feet below crown. Slide gate in corrugated metal pipe riser on the waterward slope. Concrete headwalls on both ends. Originally included in the 1961 O&M manual.					
FS Date: 9/24/2013

48-inch CMP riser on WS slope.

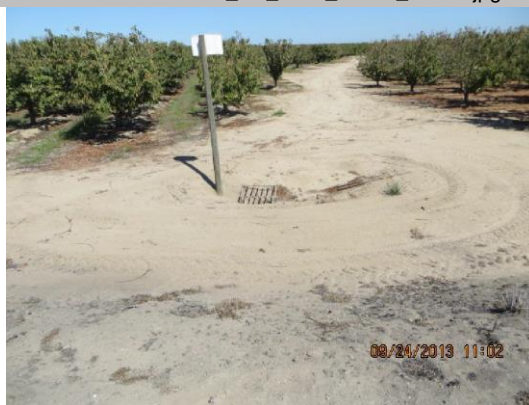
Photo 2 of 3 : UCIP_SP_2017_20945_35260.jpg

Grate over sump on LS toe.

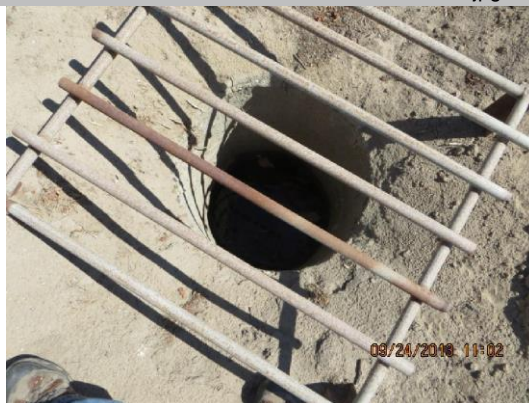
Photo 3 of 3 : UCIP_SP_2017_20945_35262.jpg

LM Start	3.47	Rating **	M	Issue No.	984 (cont)
LM End	3.47	Issue Type +	Ma	Location *	WS
Category	Supplemental			GPS Latitude/Longitude	
				Start	End
Item	DWR UCIP LMA Responsibility			37.573304 °	37.573304 °
				-121.144747 °	-121.144747 °
DWR ID					
Comment Code					
Inspector Comment					
FS_ID:20945					
DS_ID:20572					
EP_NO: N/A					
Repair Type: Non-Urgent					
Crossing Status: Found					
UCIP Comments: This pipe appears abandoned and if so, should be done so properly.					
FIELD_STRUCT_DESC: *ABANDONED* 36-inch corrugated metal pipe through levee 11.0 feet below crown. Slide gate in corrugated metal pipe riser on the waterward slope. Concrete headwalls on both ends. Originally included in the 1961 O&M manual.					
FS Date: 9/24/2013

Grate over sump on LS toe.
